T. Carson and Co

Case Study

February 6th 2002

Apasco, Estado de Mexico cement plant North Mexico City.

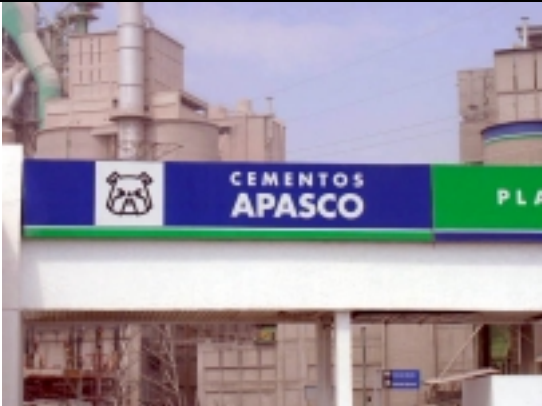
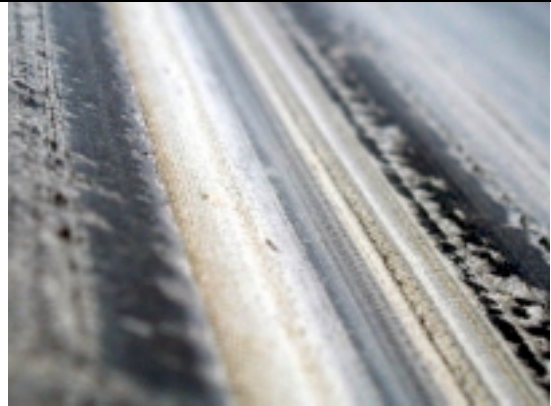
The Apasco group is one of the largest producers of cement products in Latin America. The repair was done at the Estado de Mexico Plant north of Mexico City. The belt is a 460 foot, 48 inch wide, fabric carcass with 4 plies. It has a 3/8th top and a 1/16th bottom. The damage occurred 2 days after the belt was installed when large aggregate was jammed between the skirt and the belt.

The belt was worn through the first two layers of fabric carcass leaving the third layer exposed and very vulnerable to further wear. The total width of the damage was 5.5 inches, length was 460 feet. Fortunately the damage was 6 inches from the edge of the belt and not in a high load bearing area. The repair needed to cover the exposed fabric in order to maintain belt integrity.
