Case study – Conveyor Belt Repair, HNCC Coal Mining Group

Date : 10 October 2012
 Location : Hunan Province, China
 Damage : Longitudinal rip extending 6m on an inclined steel cord belt

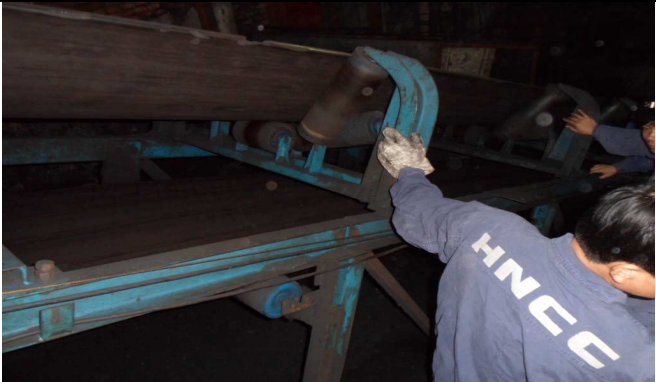
<p>To successfully repair a 6m longitudinal rip to a depth of 5mm with the top cover gouged out and the steel cord exposed. The damaged area was underground on a 26° incline slope.</p>
