Repairing a tear, gouge or rip in an industrial tire – NOT a Puncture

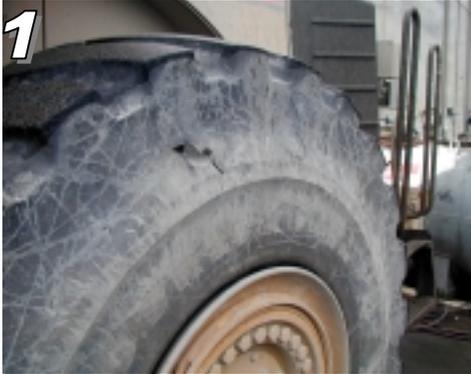
1
 Deep gouges to the side of a large off road tire are often an OSA or MSHA violation.

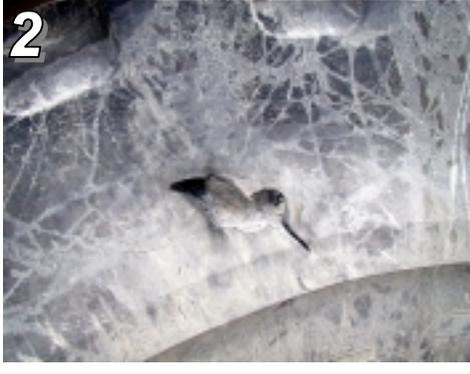
2
 The steel radials are exposed to moisture which causes them to corrode, dramatically reducing the working life of the tire
