Case study – Conveyor Belt Repair, HNCC Coal Mining Group

Date : 10 October 2012
 Location : Hunan Province, China
 Damage : Longitudinal rip extending 6m on an inclined steel cord belt

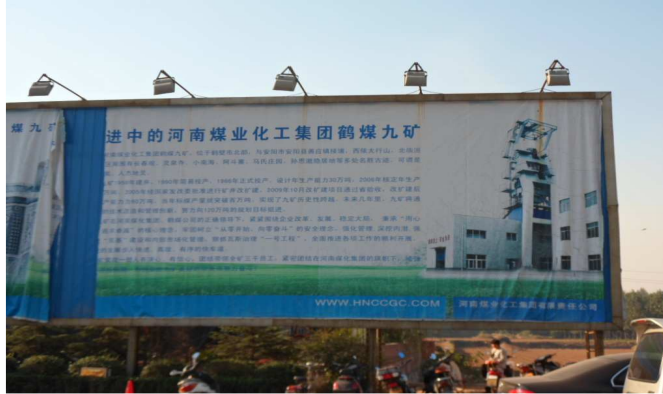
<p>To successfully repair a 6m longitudinal rip to a depth of 5mm with the top cover gouged out and the steel cord exposed. The damaged area was underground on a 26° incline slope.</p>

The repair was successfully undertaken in a total time of 3.5hrs, incl. preparation work of 30 minutes and a stand-by time of 3 hours (to allow the resin to cure).
